New Hampshire  
Department of Transportation

Scour Critical Bridge  
Plan of Action (POA) Report

Tamworth 061/091

# SCOUR CRITICAL BRIDGE - PLAN OF ACTION

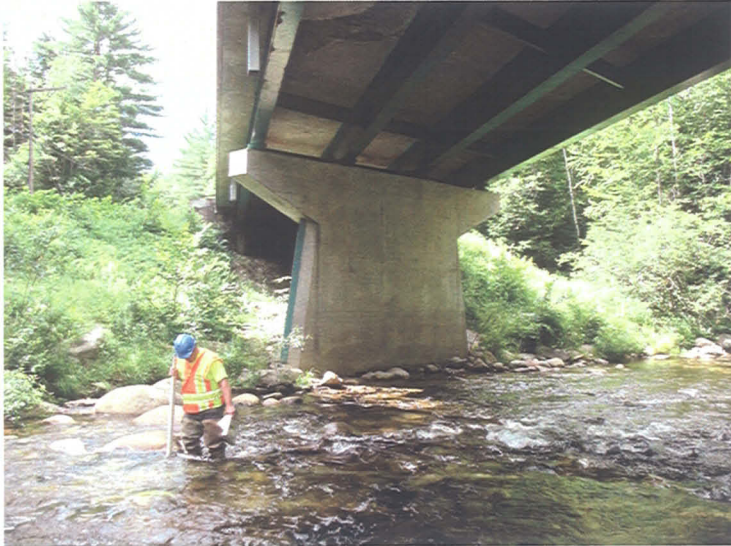
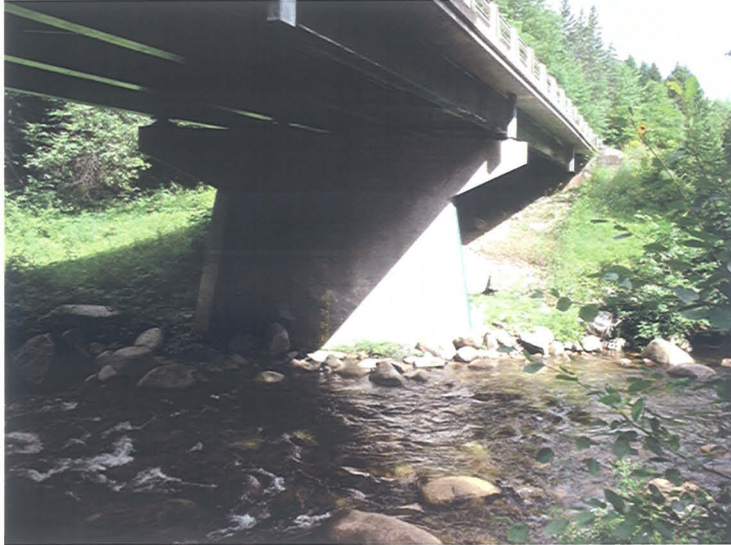
Scour Critical Feature at Low Water

Scour Critical Feature: Piers 1 and 2

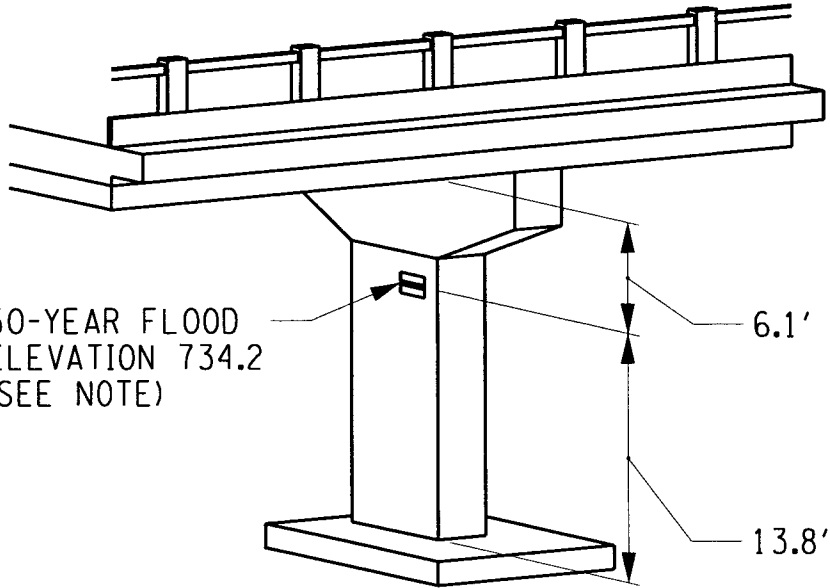
PLACARD INSTALLATION LOCATION

NOTE:  
ELEVATION 734.2 CORRESPONDS TO A 50 YEAR FLOOD EVENT,  
PLACARD LOCATION IS DOWNSTREAM NOSE OF PIER 2 ON RIGHT SIDE.

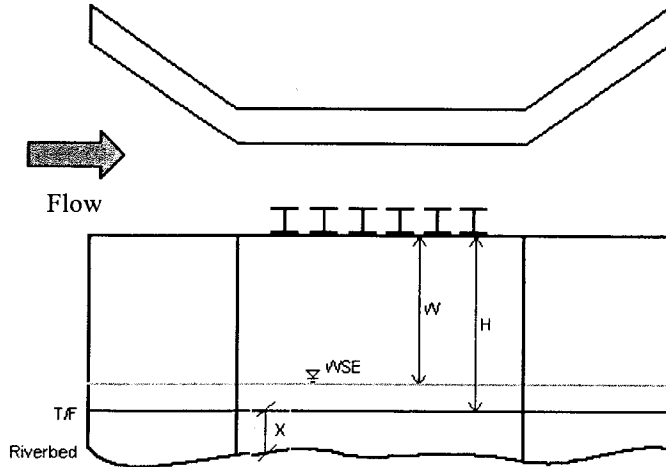
Abutment: Left

Notes: No exposure observed during 2008 inspection.

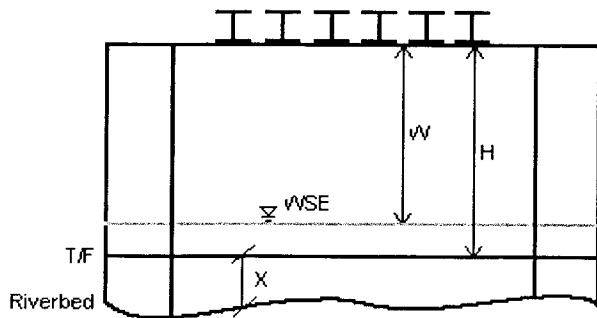
Pier: 1

Notes: No exposure observed during 2008 inspection.

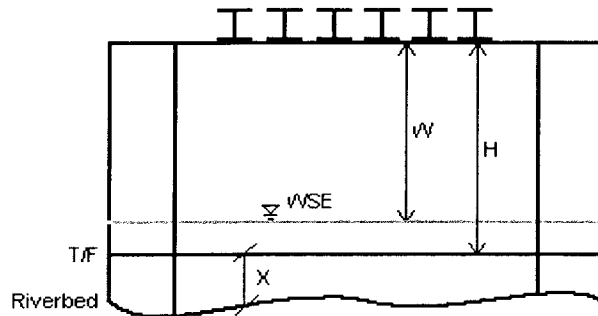
Pier: 2

Notes: No exposure observed during 2008 inspection.

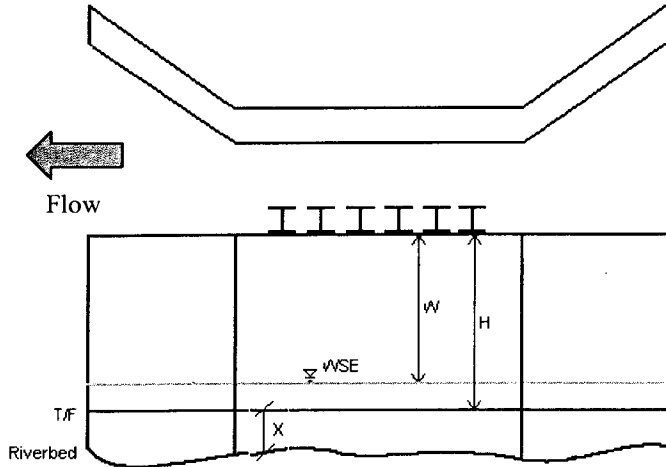
Abutment: Right

Notes: No exposure observed during 2008 inspection.

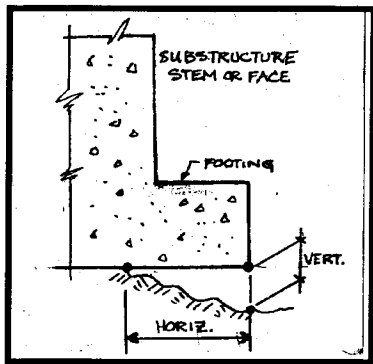
Notes: No undermining found during 2008 inspection at any substructure unit.
